Date: May 2014

Risk of derailment because of threat overheating wheelset bearing box

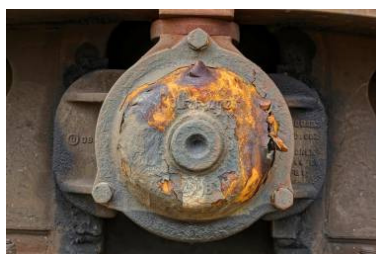
Investigation showed that one of the 3 bolts inside the bearing box had come out its bolt hole. The head of the bolt had come off the stem and both parts had been flying around the bearing box at high speed causing the overheating of the box. The two other bolts were seriously bent due to the high stress forces generated in the absence of the 3rd bolt. The overheating caused immediate rust formation on the bearing box.

Rust formation due to overheating

Check what type of bolts are fitted in the axle bearing boxes and if necessary, replace them by bolts with locking plates during the next entry of the rtc into the workshop for check up of the rtc and revision wheelset of the type IS2 (full revision) and IL (revision of bearings)

RTC inspectors and loading- unloading operators must pay extra attention to the visual condition of the axle bearing boxes (see pictures)
