# A Bag In Box container slid from the chassis during tipping

## Logistics SHE Alerts

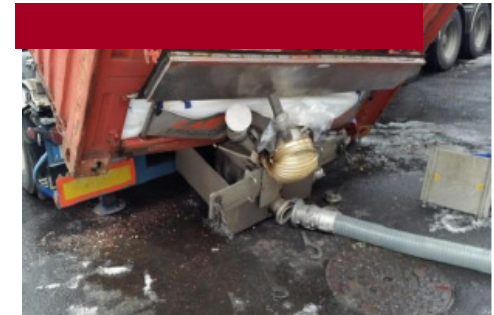
- During the tipping, a BIB container suddenly slid approximately 0,5 m from the rear of the chassis.
- The movement stopped as both the delivery equipment hit the ground and the underside of the container became stuck/wedged on the chassis. This punctured the fibre glass floor of the container but did not breach the inner floor of the container or liner.
- No one became injured.
- 50 kg of product were spilled

- The incident was caused because the driver had failed to engage and to check the twist locks. This caused the container to slide over the top of the twist lock mushrooms.
- On the delivery checklist, the driver had indicated that he had done the checks which was not the case.
- The driver had applied an incorrect sequence of lifting and activation of the rotary valve as he had started the tipping before activating the rotary valve. As the rotary valve was not yet powered, the amount of product spilled remained very low.

- Before tipping, it must be checked that all twist locks are engaged and secured in locked position. Preferably, there should be a cross check by a site representative.
- Although the chassis was fitted with heel plates, these did not prevent the container to slide back and off the rear.
- Drivers must remain outside the danger zone while tipping.
- Ineos O&P have made the installation of twist lock indicators on tipping chassis mandatory as from mid next year.
