TT-LO-105

Manhole lid ejected during unloading

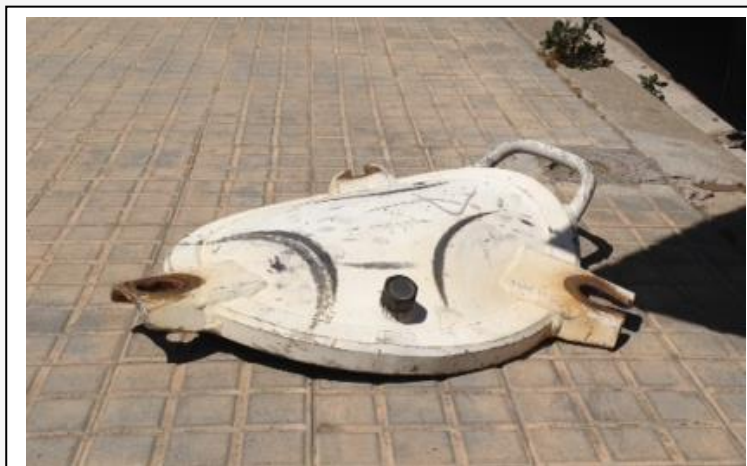
During an unloading operation of Polyethylene, one of the lids of the manhole on the top of road tank ejected (see picture on the left)

One of the 3 double hand nuts to close the lid failed and the lid was ejected.

The most likely root cause of the failure is due to an inaccurate integrity check of the thread of the double hand nut.

The man lid system was one of the older systems. The lid is fixed on the silo with three bolts.

- Carrier will not send trucks with only 3 double hand nuts to close the lid. All trucks will be 4 double hand nuts to close the lid to avoid this happen again
- The carrier, who is responsible for the maintenance, need to check carefully the integrity of all equipment on a periodic basis

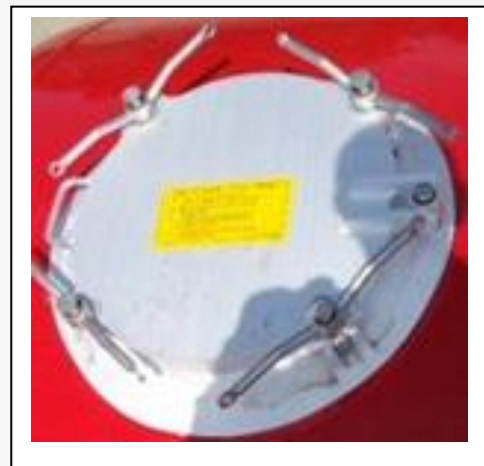
The newer systems are equipped with 4 fixing bolts and a hinge, which is connected at the silo. Most of these newer systems have also a safety head (see picture on the right) on the screws which will prevent that the female lid of the screw can be

expelled from the lid. This system is reducing the risk of expelled lids as happened during this incident.
