# Driver hit by a passing forklift during discharge operation

At customer (O&P North)

Logistics SHE Alerts

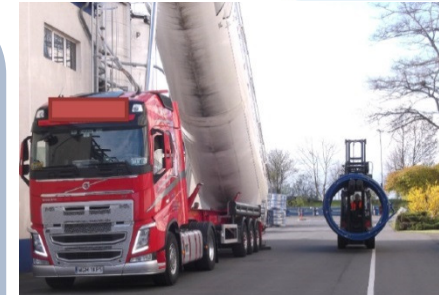
Forklift with coil passing the truck that is being unloaded. The driver who was standing at the right side, went to the left side of his truck when the incident happened

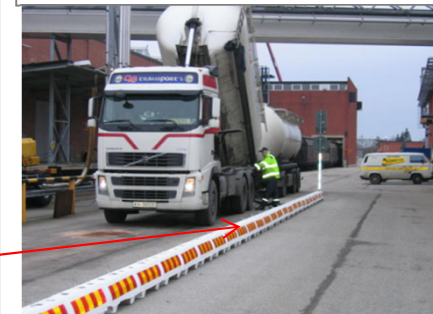
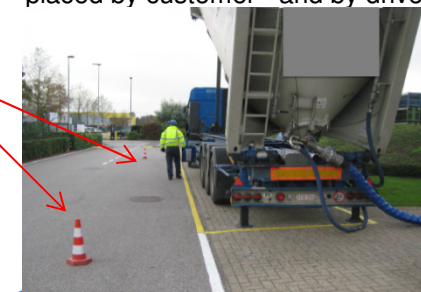
Examples of physical segregation placed by customer - and by driver

Customers are strongly advised to provide a physical segregation between the unloading area and passing traffic, by means of barrier tape, concrete/ plastic barriers etc. In the absence of these, hauliers are advised to provide plastic cones to the drivers which can be placed between the truck and passing traffic.
