Wing nut of manhole detaches and flies away during discharge bulk silo truck

NON INEOS incident at 3rd party terminal

Logistics SHE Alerts

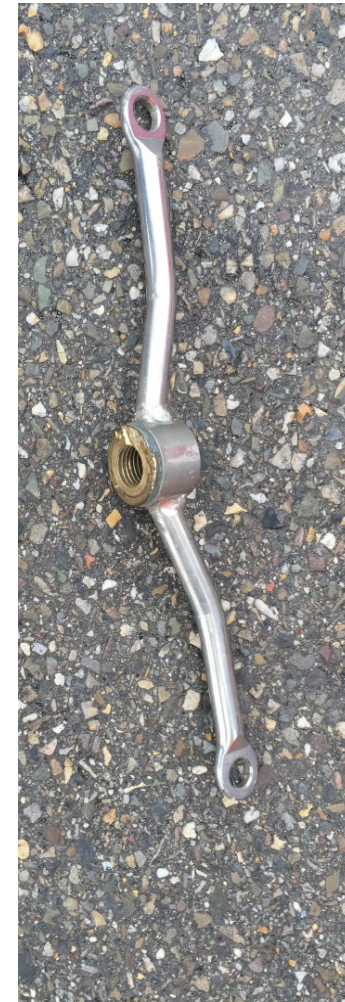
Suddenly, a (wing) nut of one of the manholes detached and flew away through the air.

The driver who unloaded the truck noticed when checking the tightness of the nuts that one nut was hard to turn. This is the nut that flew away.

The screw-thread appeared to be damaged, possibly by overtightening.

During unloading, the force on the nuts of a manhole can exceed 1000 kgf because of the air pressure inside the silo.

Turning the nut when the bulk silo is pressurised, damages the screw-thread.

Drivers must be aware that a nut which does not turn easily can be damaged resulting in a dangerous situation therefore these have to be replaced.

When tightening the nuts, it is important not to use excessive force as this could lead to failure of the screw-thread.

When the screw-thread of a nut is damaged, the forces in the remaining nuts are unevenly distributed. This can cause failure of the other nuts followed by the manlid suddenly blowing open.

Never tighten the nuts when the bulk silo is pressurised!
