# Container slides off the chassis

NON – INEOS accident

Logistics SHE Alerts

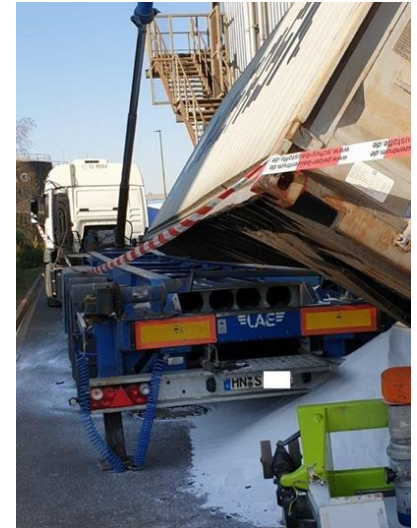
Opened!  
No departure!

**The twist lock has to be turned 90° to create a connection.**

**The twist lock has to be checked for proper locking before each departure and before tipping of the container. This must be done on each twist lock individually.**

**In addition, the locking of the twist locks must also be checked by using of the so-called „warning flags“ before departure, via the rear view mirrors!**
