Implementation of Cefic/ECTA best practice for unloading polymers in bulk

Brussel, 21/11/2019

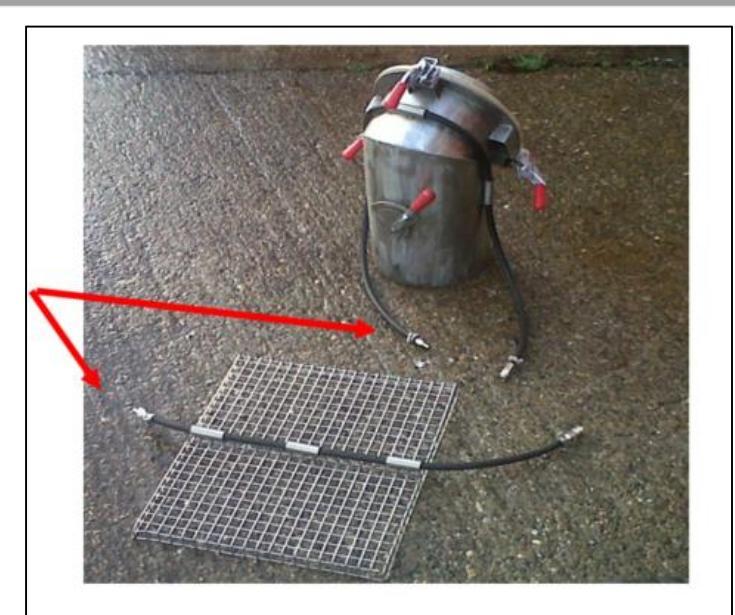
INTERLOCK PROTOTYPE

Air pressure control valves have been added to act as circuit breakers on the Rotary Valve. The air pressure conduit runs over the flow control valve, and connects to two points (one on each side) of rotary valve.

Both air pressure control valves must be fitted to complete the 'circuit' allowing the rotary valve to be energised. (Also see image below)

The main challenge we faced was related to the design and installation of an interlock system for the safety guard of the rotary valve.

2016: a prototype was designed and tested.

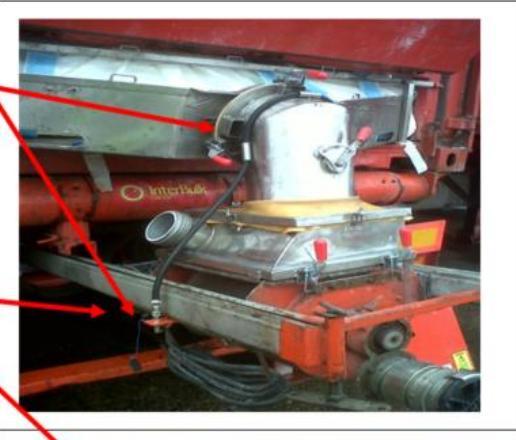
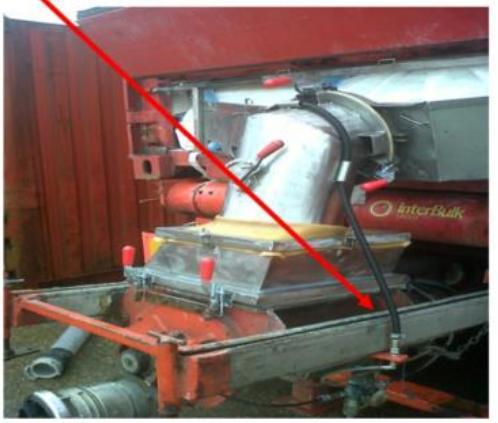
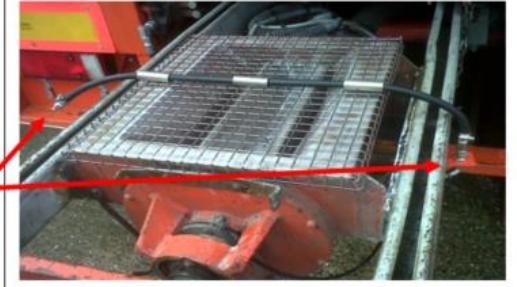
In order for the driver to energise the rotary valve for cleaning the safety grid must be in place with <u>both</u> air pressure control valves connected to complete the circuit.

With only one air pressure control valve connected the circuit is not complete, and so the rotary valve cannot be energised.

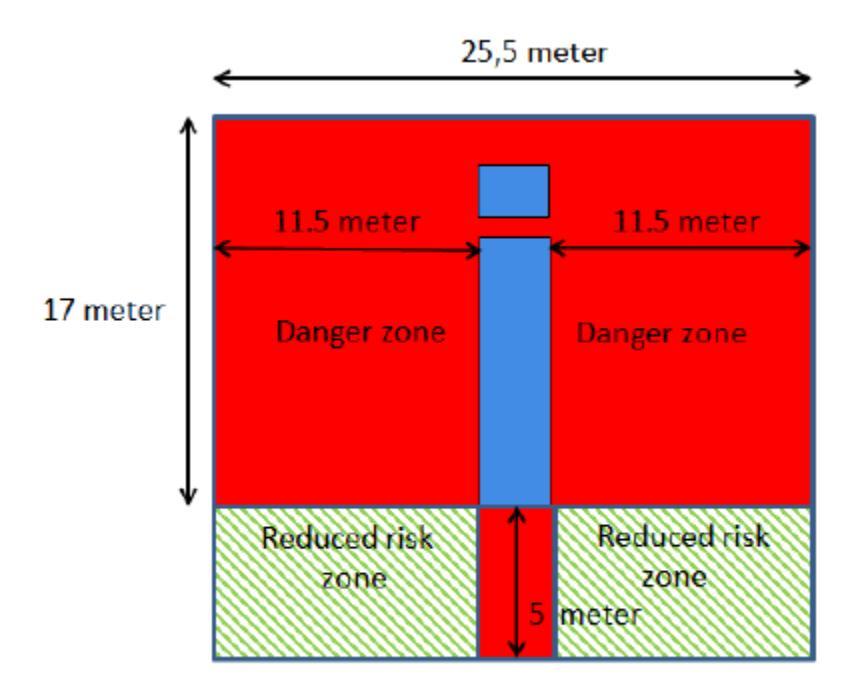
Danger zone for 30' container

Safety clearance in all direction is rarely achieved by receivers, due to pre-existing site layout.
