Incident number 120

## PE spill unloading, unsafe truck position.

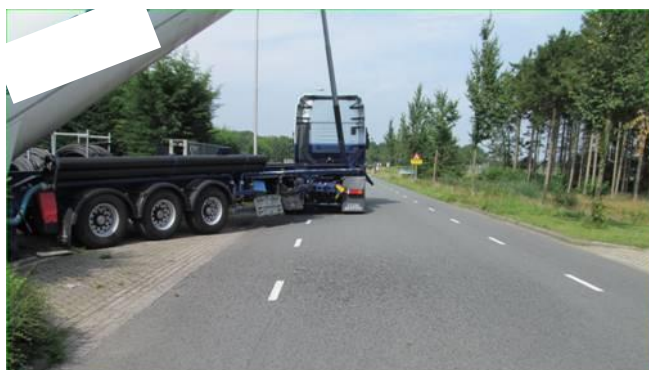
### Insert a picture (if available)

During unloading of silo truck, hose came loose and 200 Kg of product was spilled on the floor. Driver aborted operation immediately. Driver with plant operators collected all product and clean the area.

The layout of the unloading area did not allow the Truck and Silo position in a straight line.

Truck partly parked on public road at factory premises exit. Truck cabin front located on the opposite lane causing potential danger for the circulating traffic. Driver followed instructions from plant operator to perform unloading accordingly in order to avoid cut off road circulation.

Obstacles between the plant and truck connection points caused the hoses could not installed properly, which caused the hose came loose.

All involved parties have been in contact to seek for alternative solutions to prevent re-occurrence and causing unsafe situations.
